Navajo Abandoned Uranium Mine Site Screen Report

Desidero Group Uranium Mines

Navajo AUM Eastern Region

Weston Solutions, Inc.

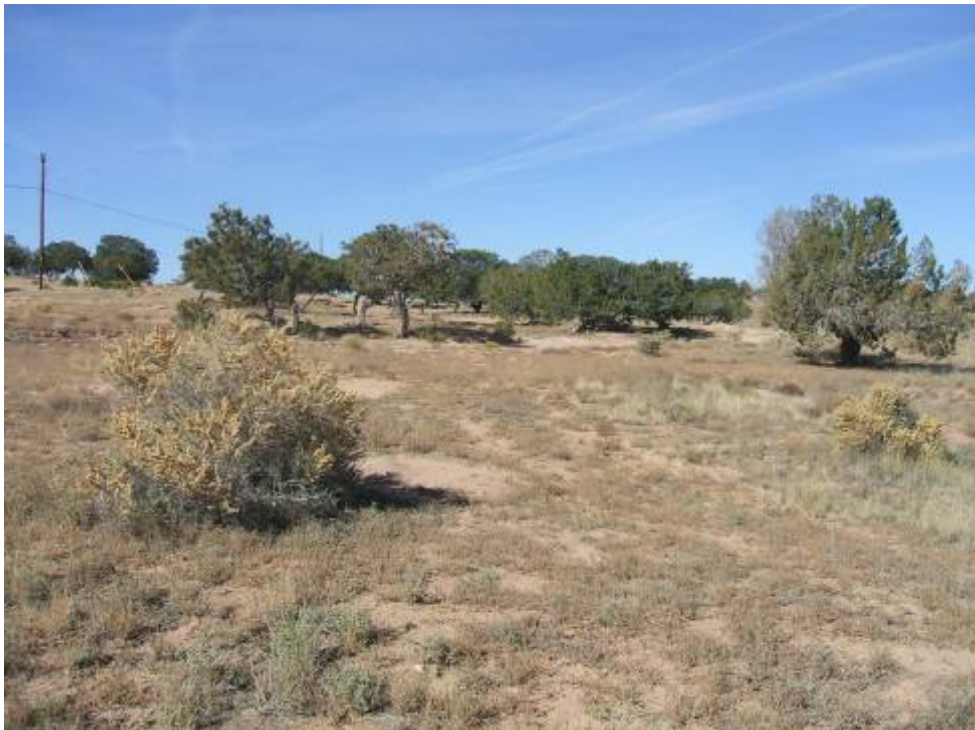
Photo 1. Western site area of Desidero Group mine site, towards the west

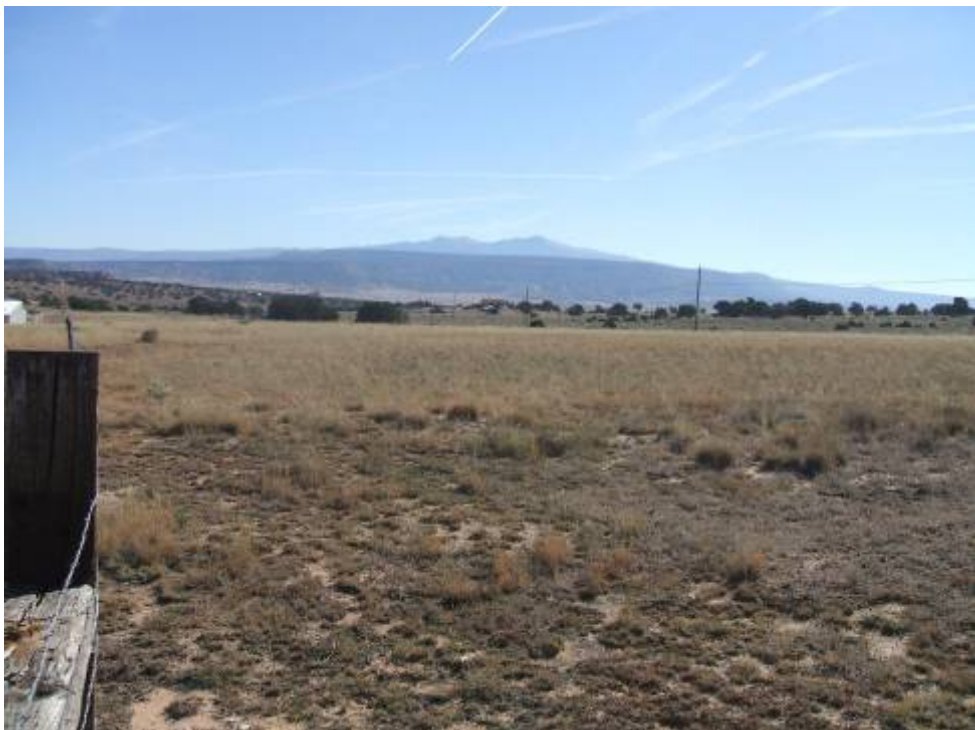
Photo 2. Western site area of Desidero Group mine site, towards the east

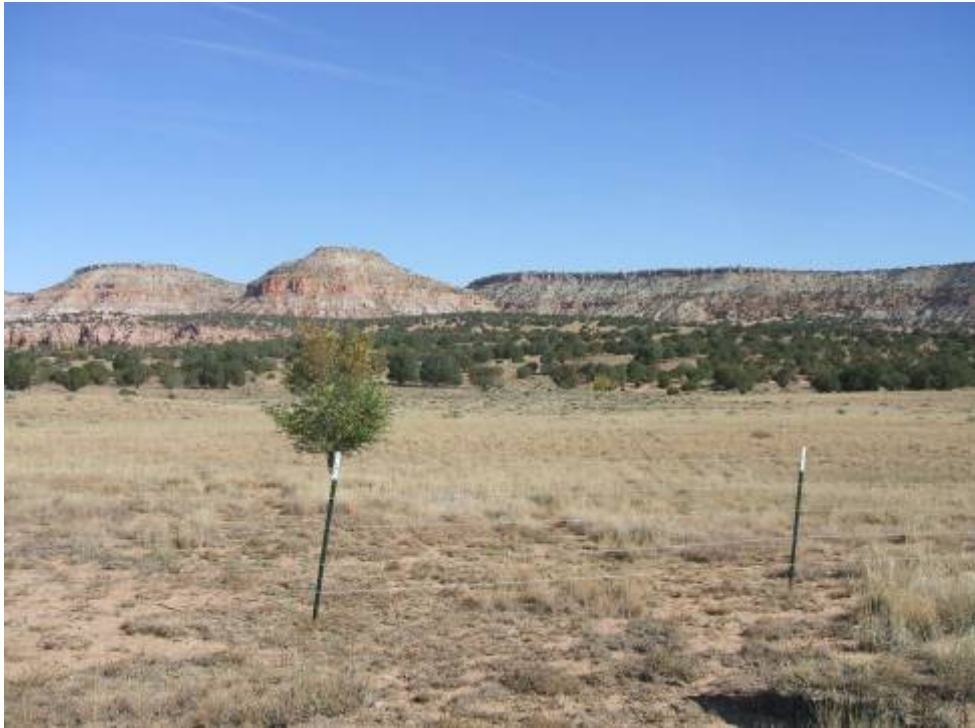
Photo 3. Former open-pit area of Desidero Group mine site, directly adjacent to the western site area of Section 26 mine site, towards the north

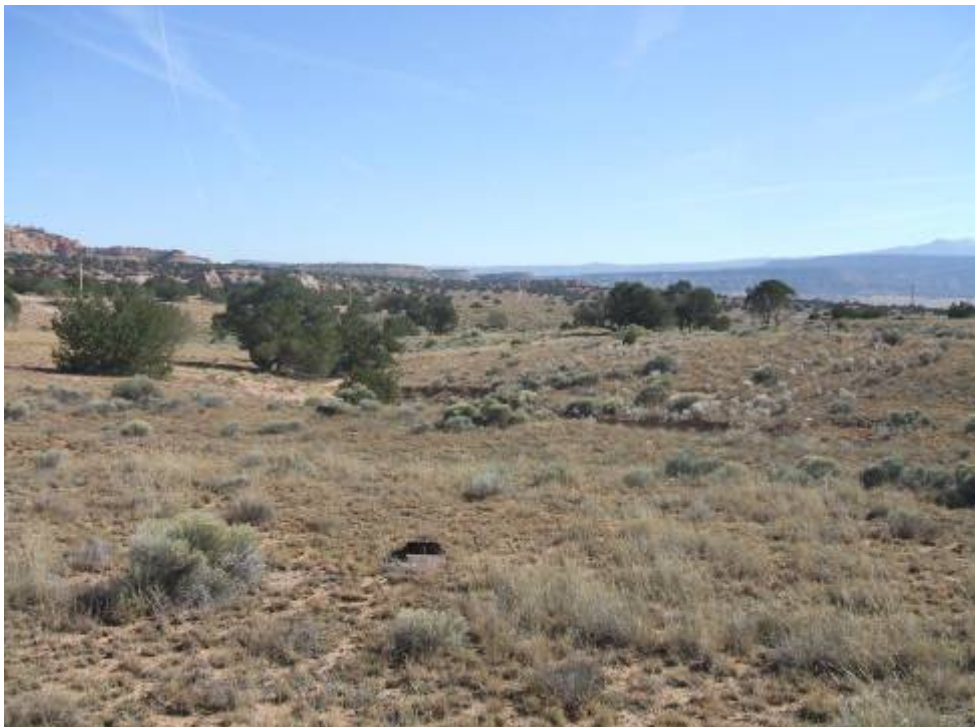
Photo 4. Eastern site area of Desidero Group mine site, towards the east

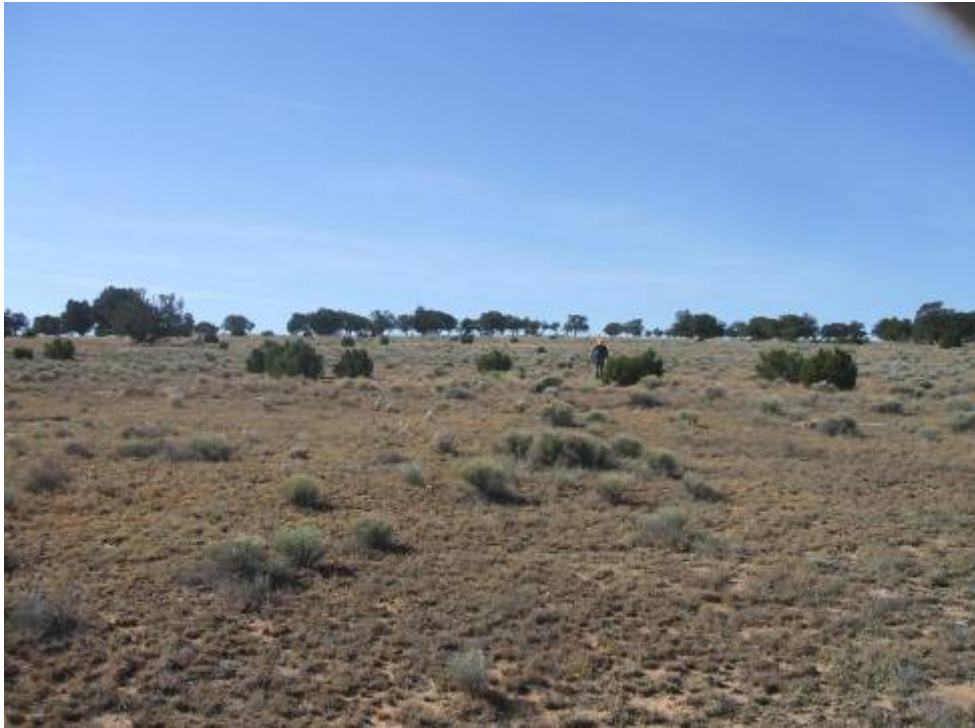
Photo 5. Eastern site area of Desidero Group mine site, towards the south

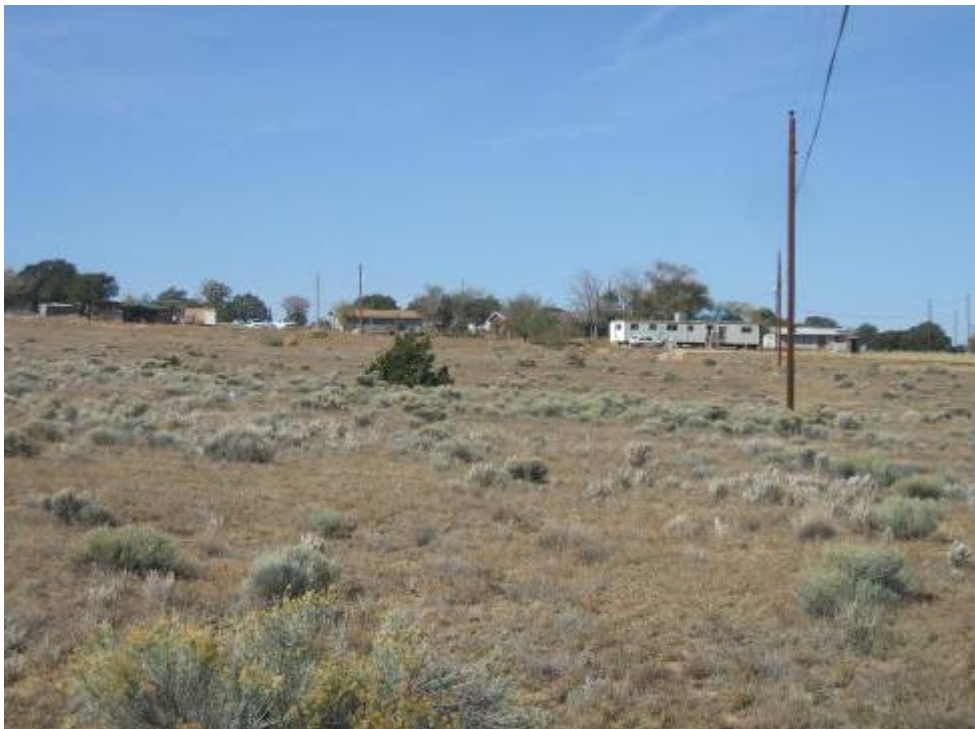
Photo 6. Houses and trailers located approximately 500 feet south of mine site, towards the south

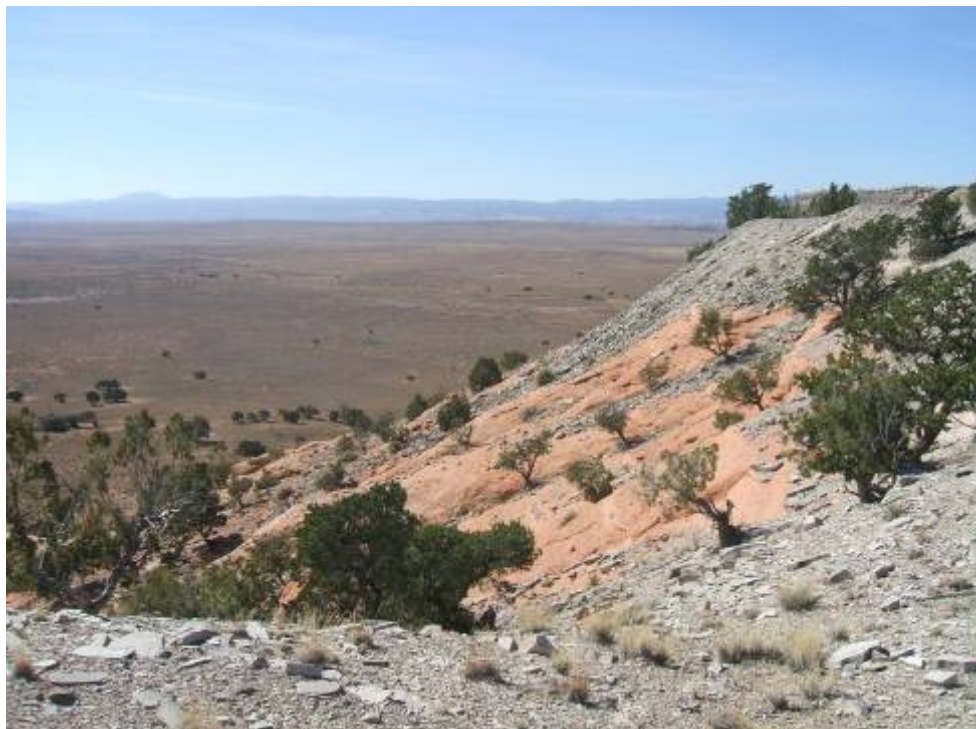
Photo 7. Southern site area cliff of Desidero mine site, towards the south

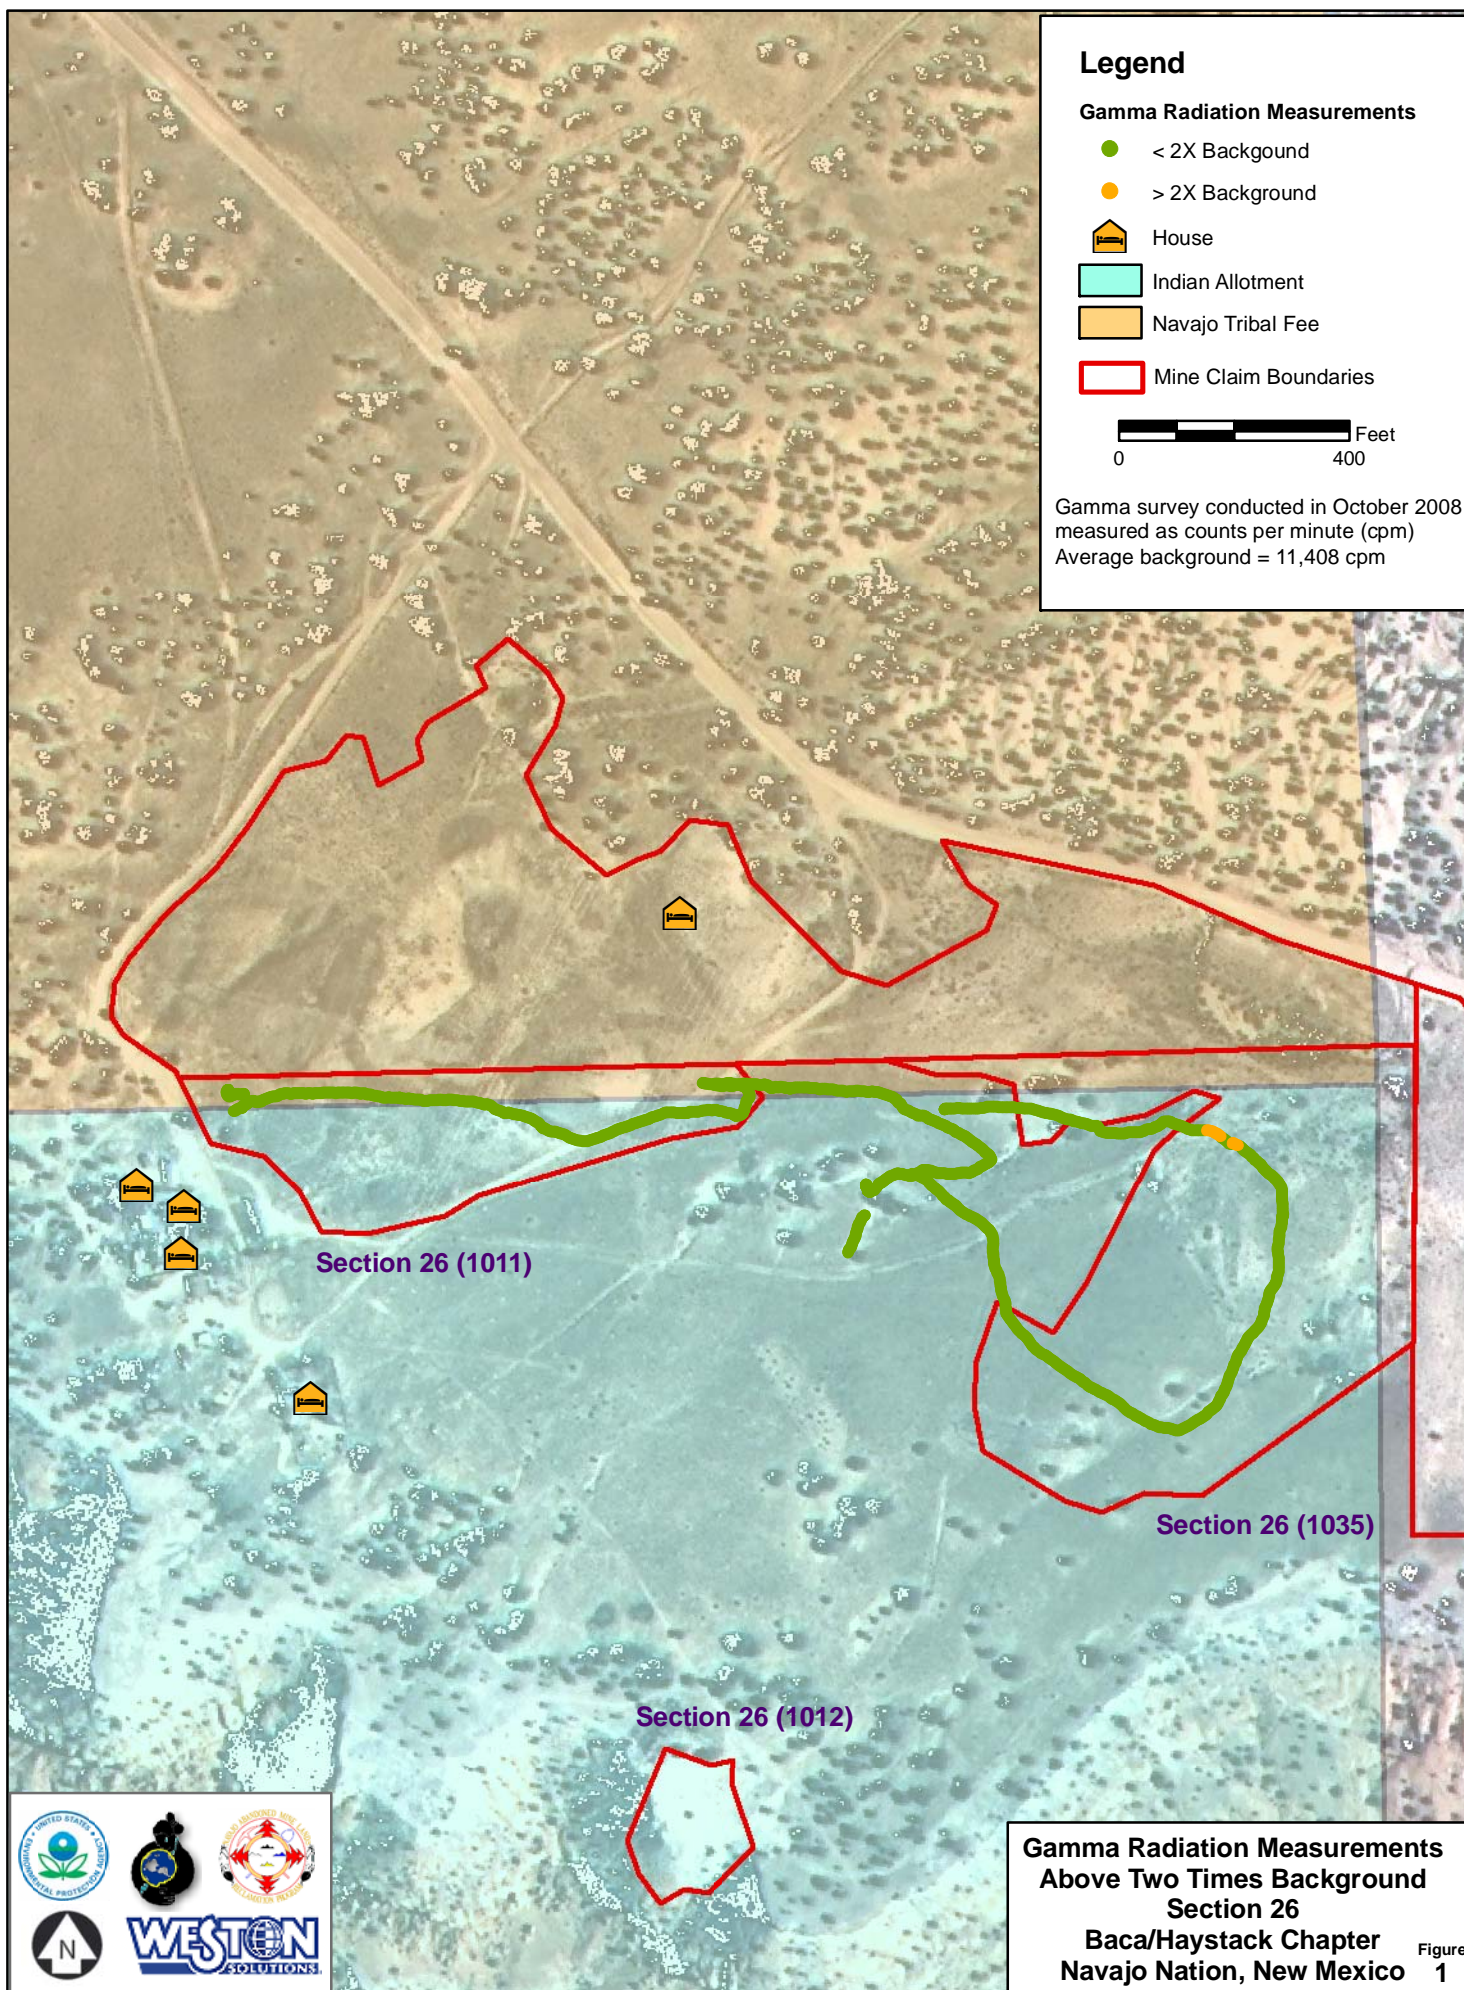
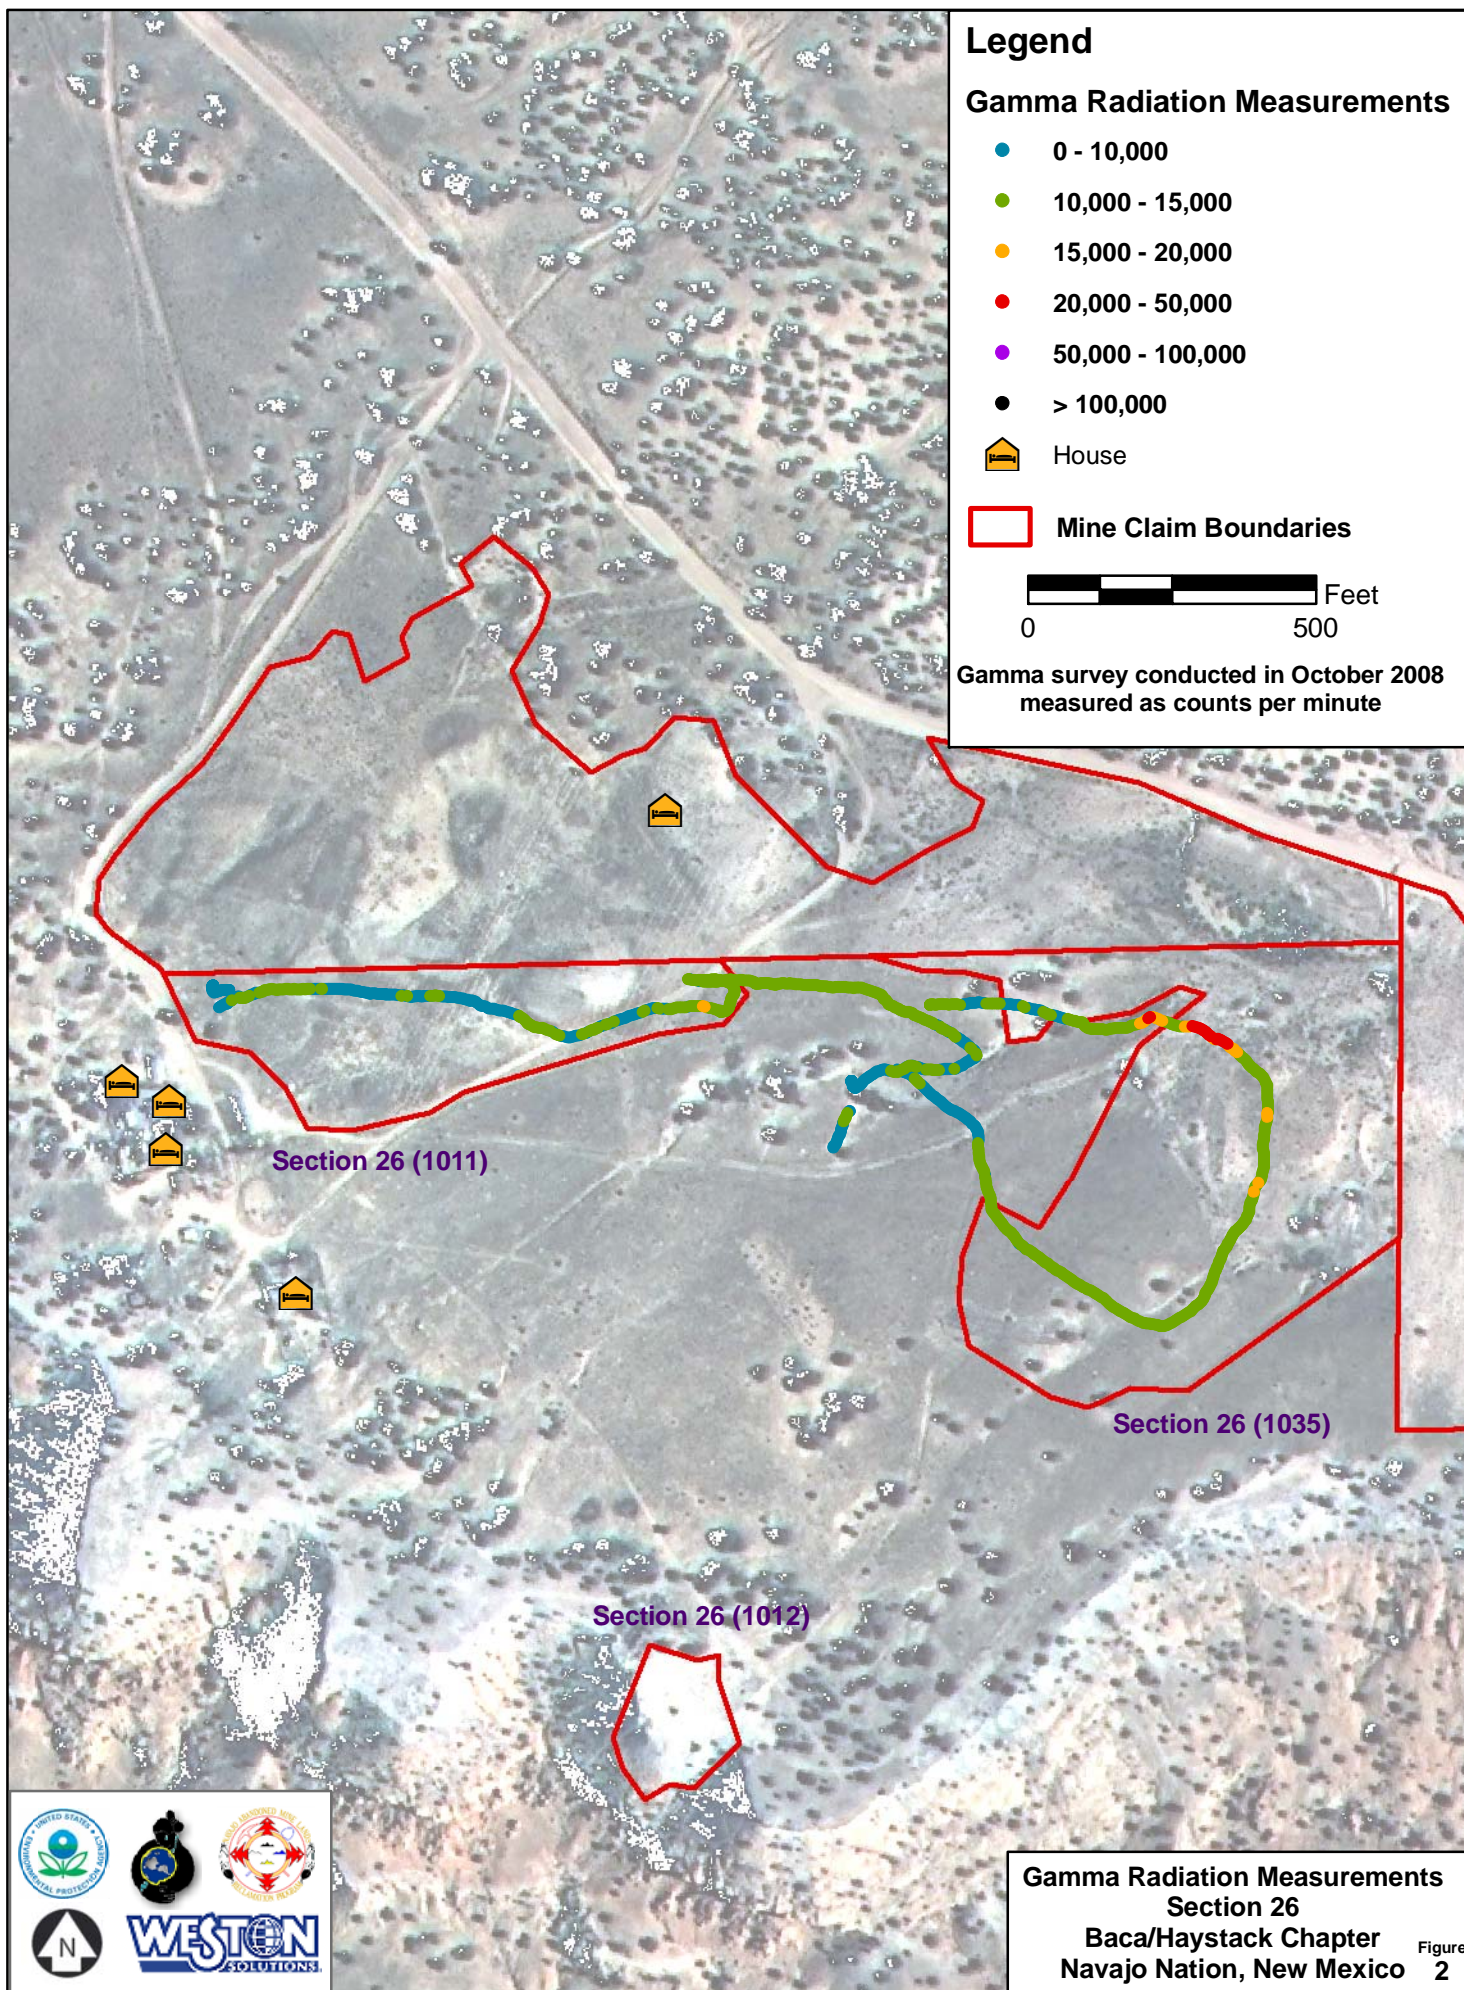
A total of 1,195 gamma radiation measurements were collected from mine sites, ranging from 7,937 cpm to 37,450 cpm. The measurements are represented in Figures 1 and 2.
